ENHANCING AND DEVELOPING SEISMIC RISK ASSESSMENT FOR BAGO CITY OF MYANMAR

Safer Coastal and Urban Communities through Inclusive Disaster Risk Reduction in Myanmar

Project Funded by DIPECHO

December, 2015

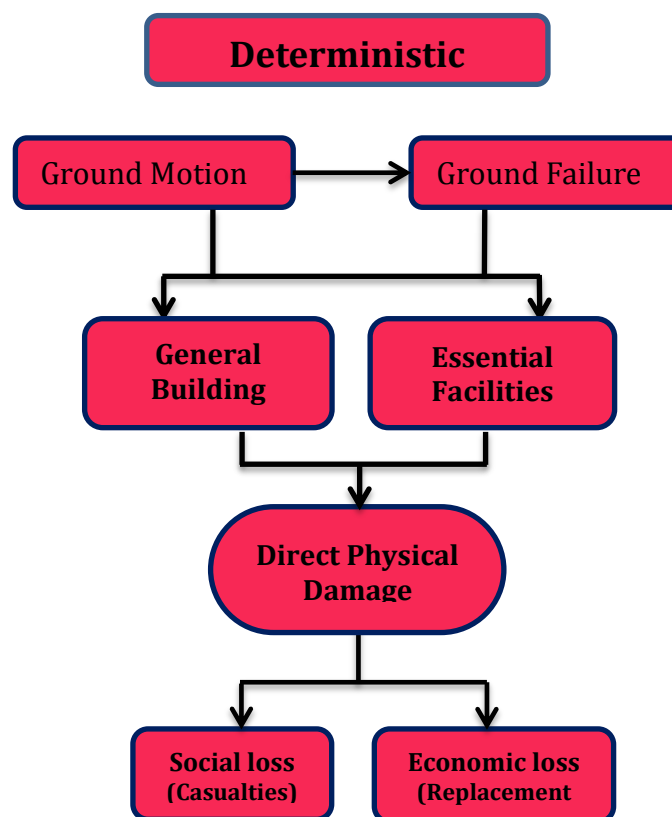
Figure (4) Flow Chart of the Earthquake Loss Estimation Methodology adopted by HAZUS

HAZUS methodology for earthquake loss estimation model is herein used for this project. The earthquake loss estimation methodology can develop the preliminary estimation of damages to prepare before disaster situation and to plan and stimulate efforts how to reduce probable risk from earthquake. Socio-economic profiling and inventory of critical infrastructures of Bago City is undertaken by surveying in the field. Perform 3D and Etabs structural software are used for the analysis of representative building types in Bago City. HAZUS and Arc GIS Softwares are used in the development of probabilistic seismic hazard map of Bago City.

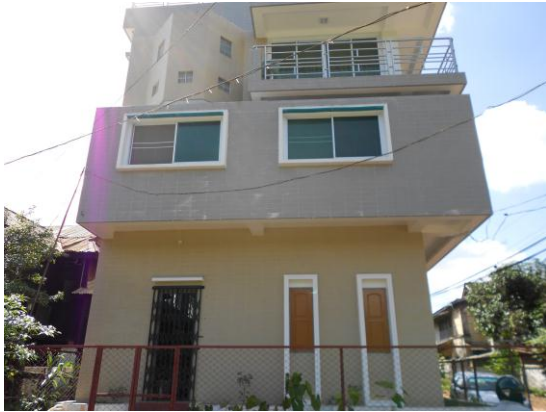
Reinforced Concrete Building (RC)

Timber (W1)	Timber, Light Frame (< 5,000 sq. ft.)
Brick-nogging (RML)	Unreinforced Masonry Bearing Walls with Wood Diaphragms
Brick Masonry (URML)	Unreinforced Masonry Bearing Walls
Reinforced Concrete (RC)	Concrete Frame with Unreinforced Masonry Infill Walls
Mixed-use (MH)	Other Type of Building or Mixed use buildings
