SHELTER PROJECTS 2009

Shelter Projects 2009

Published 2010

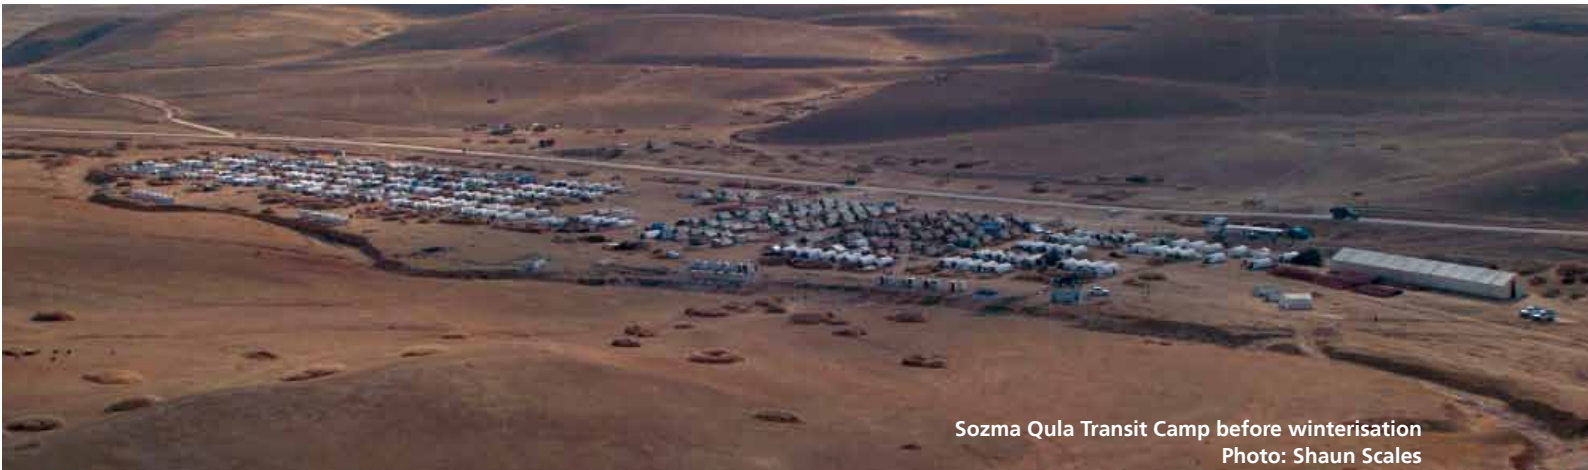
Sozma Qala Transit Camp before winterisation
Photo: Shaun Scales

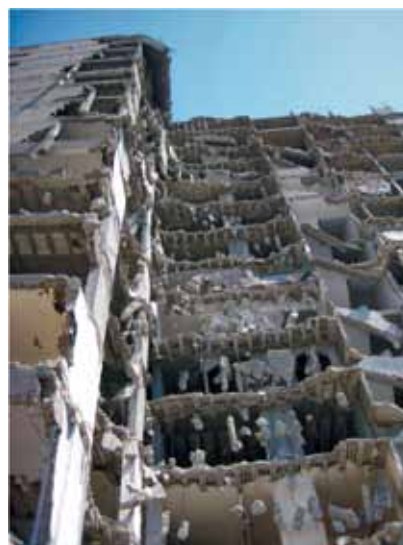
Where buildings had many tenants - different apartments were assessed separately from the building
Photo credits: CHF

Damage was further categorised into apartment damage and damage to the common parts of a building. This was to enable tenants of multi-storey structures to qualify for assistance.

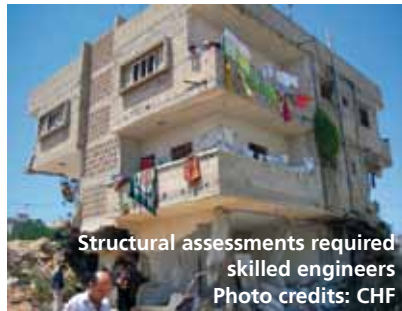
Structural assessments required skilled engineers
Photo credits: CHF

Three different damage assessment methods were identified. Each had corresponding forms and paperwork.

Category 1: repair is not feasible. Assessment teams must collect additional data such as area of the building, the number of floors, original drawings or photos of the building and type of finish.

Category 2: damage is too complex. A specialist team is required to assess the damage. This was most common for multi-story buildings where there was damage to slabs or structure in lower floors.

Category 3: partial damage or rehabilitation is feasible. Three categories were established: excessive, moderate or minor damage.

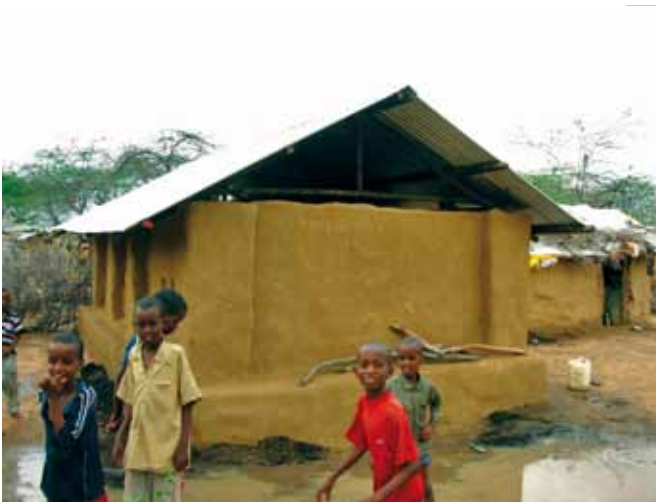
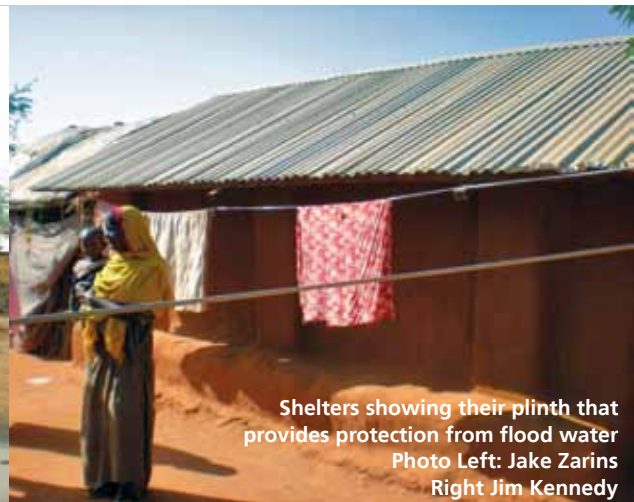
Shelters showing their plinth that provides protection from flood water
Photo Left: Jake Zarins
Right Jim Kennedy

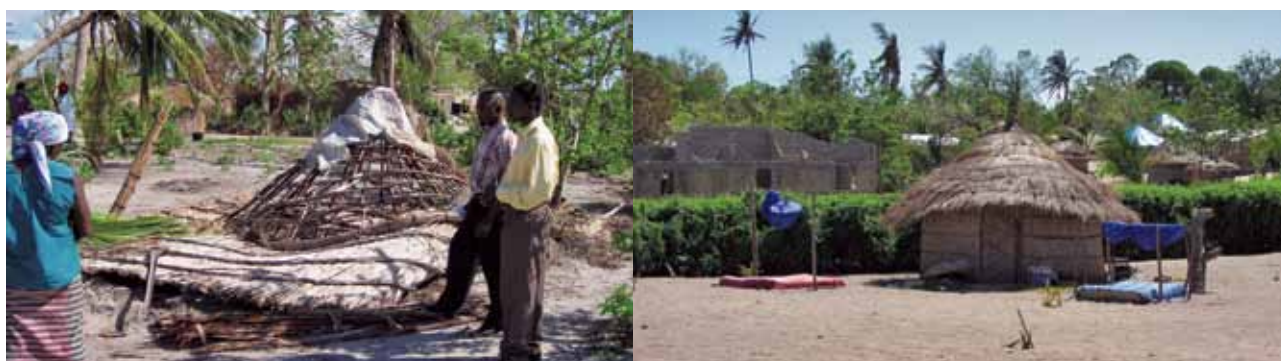
Left: a damaged house. Right: self-built reconstructed house using items distributed.
Photo: Lizzie Babister

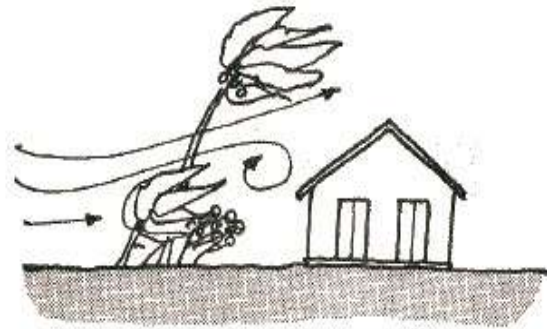
Trees can help protect houses from wind damage
