SHELTER PROJECTS 2008

IASC Emergency Shelter Cluster

Shelter Options 2008

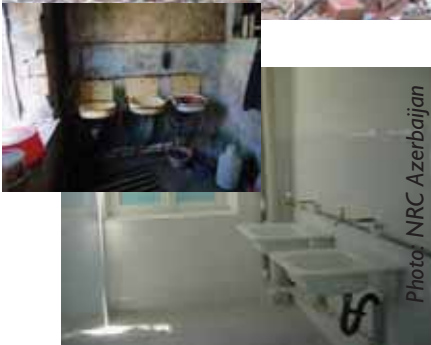
Bathrooms before and after upgrade

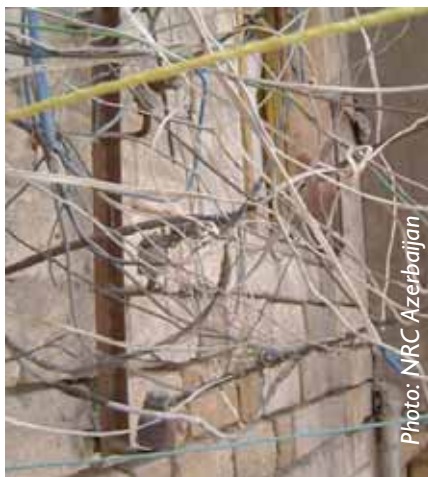
Wiring before upgrade

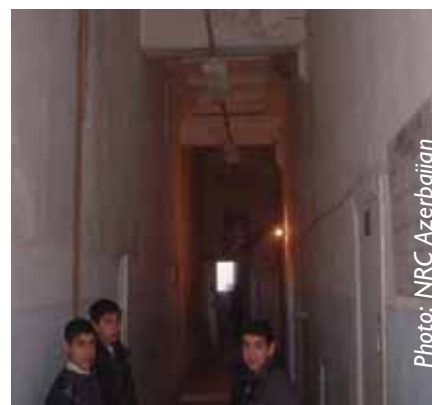
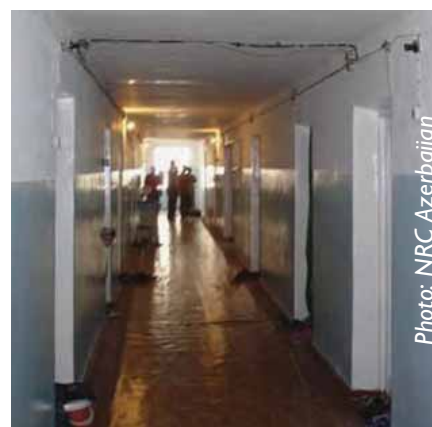
Corridors before and after upgrade

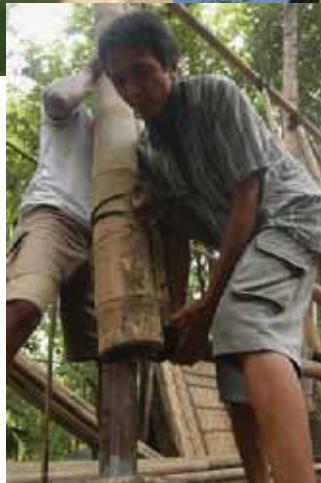
Connecting a vertical post to the foundation

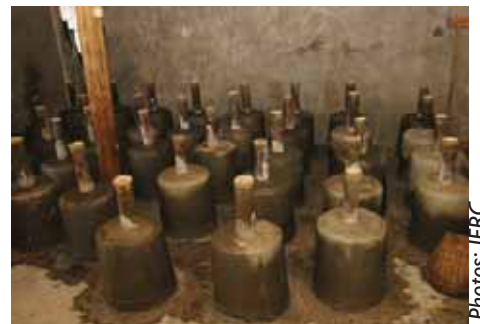
Foundation pads cast with bamboo to connect them to the frame

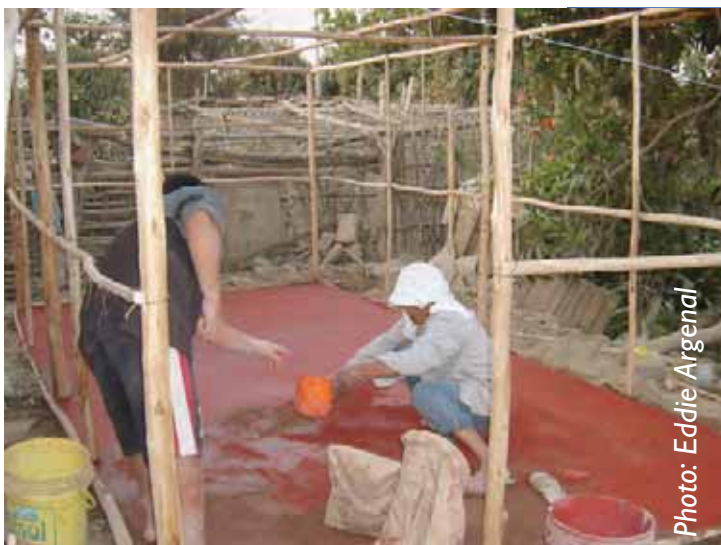
Making the concrete floor slab

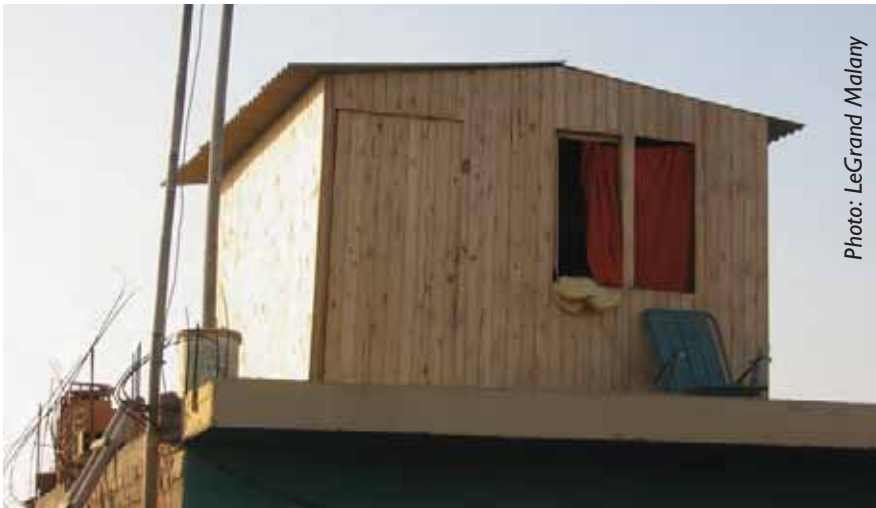
Completed shelter built on the roof of a damaged house
